THE COMBUSTION CHARACTERISTICS OF MICROFLOOR RAISED FLOORING SYSTEM

Submitted to : Messrs Campbell Davies and Partners
P O Box 651525
Benmore
2010

Contract Number: 59869/32

DIVISION OF BUILDING TECHNOLOGY : CSIR
P O Box 395 Pretoria (0001) Republic of South Africa

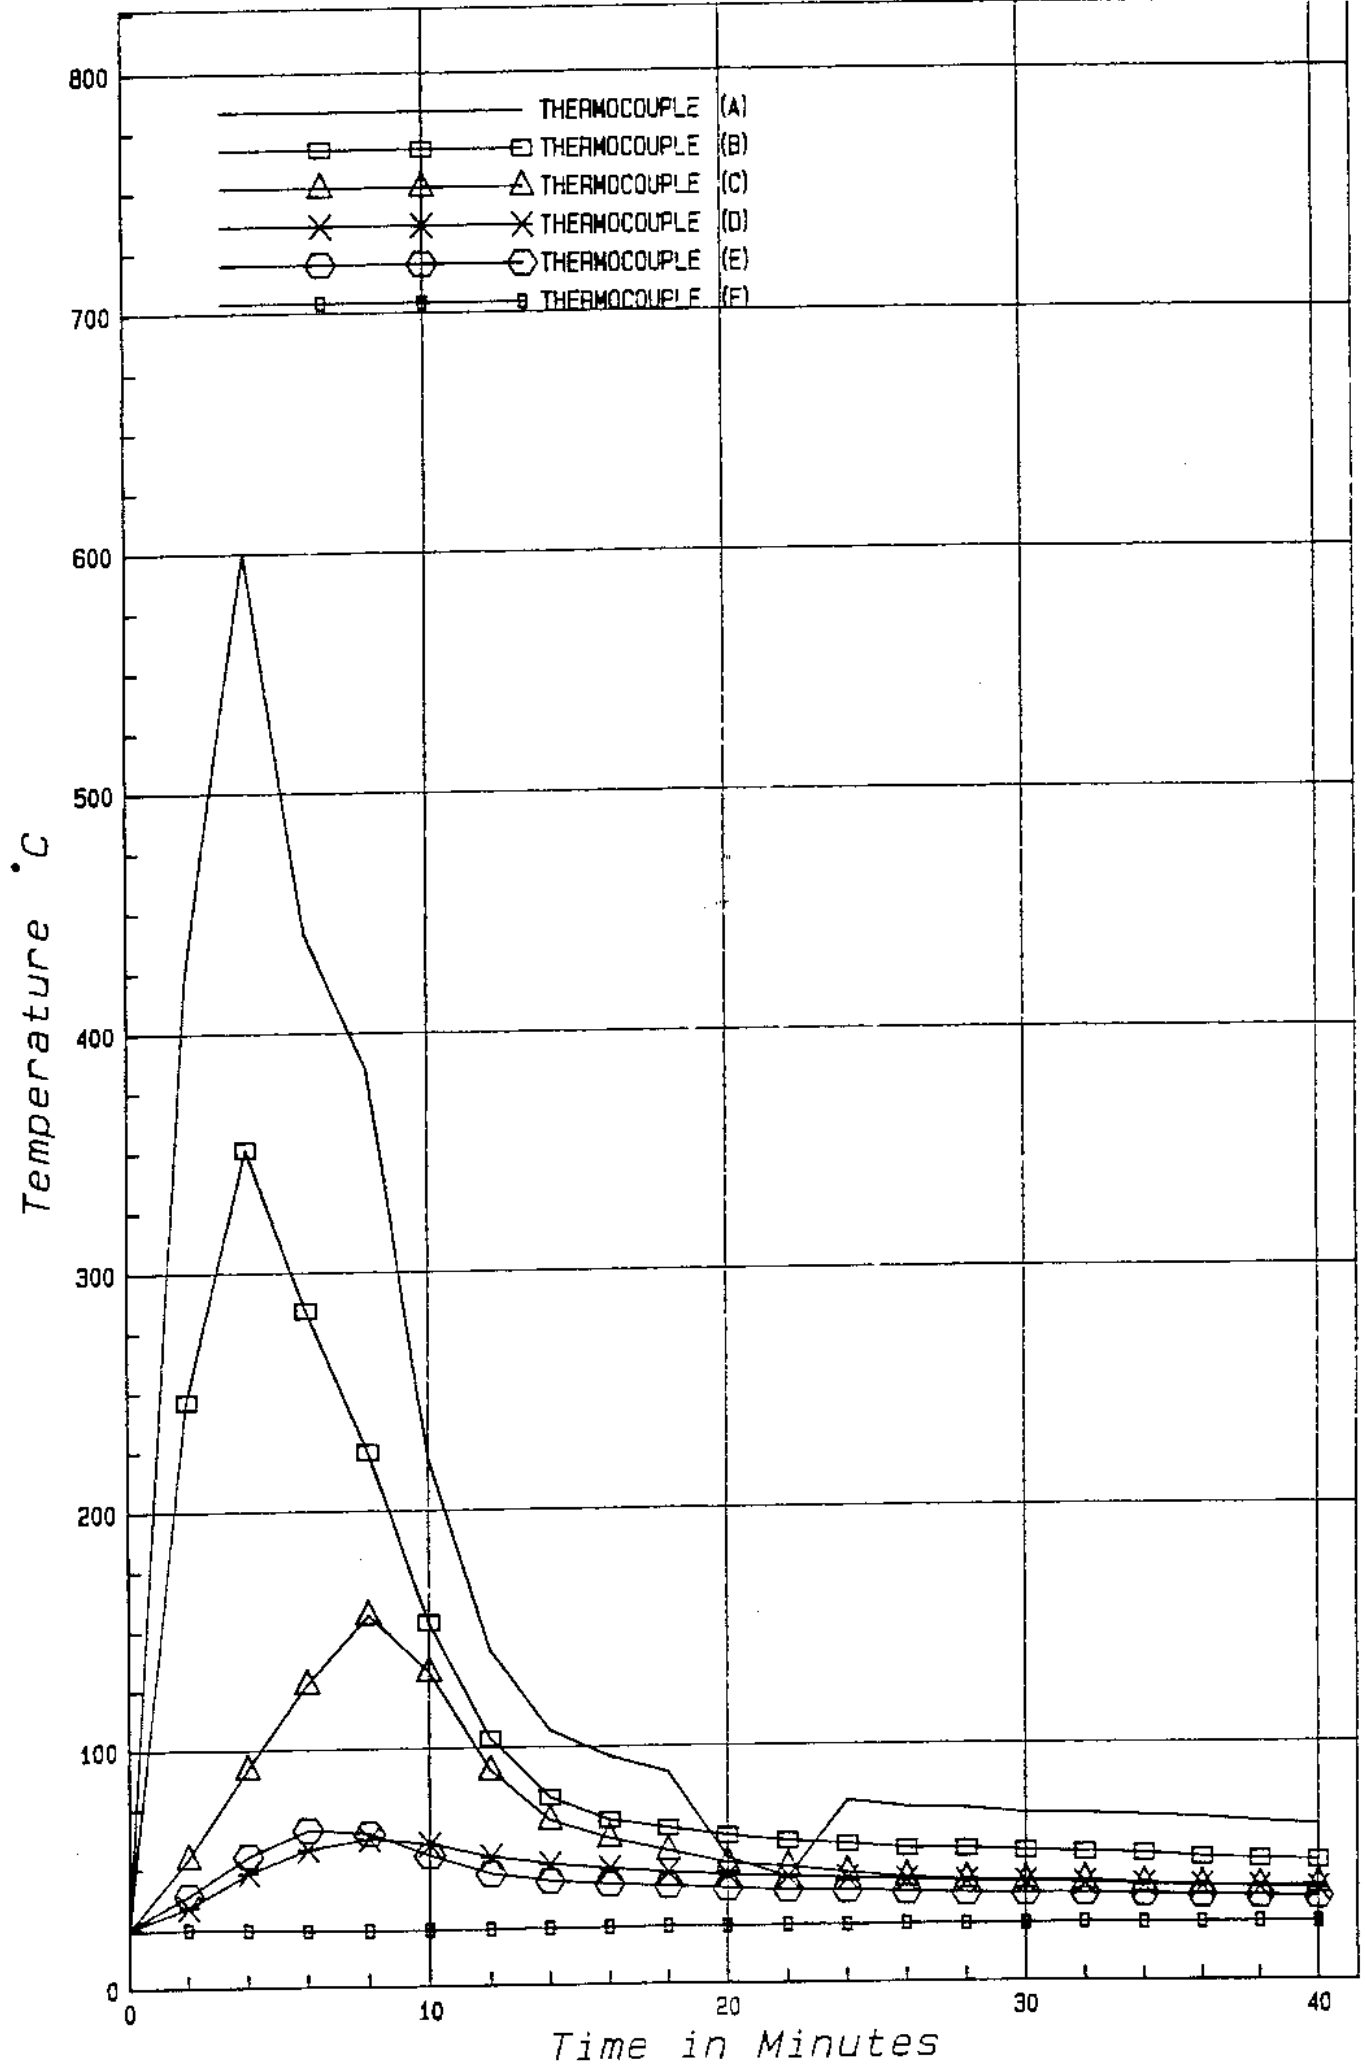
Figure 1 : TEMPERATURES RECORDED DURING TEST :

C D P - MICROFLOOR - 93:06:23

The temperatures measured during the test are presented graphically in Figure 1.

Both visual observations and the temperature measurements indicate that the Microfloor system does not propagate flame and is essentially self extinguishing when out of the influence of an external ignition source.

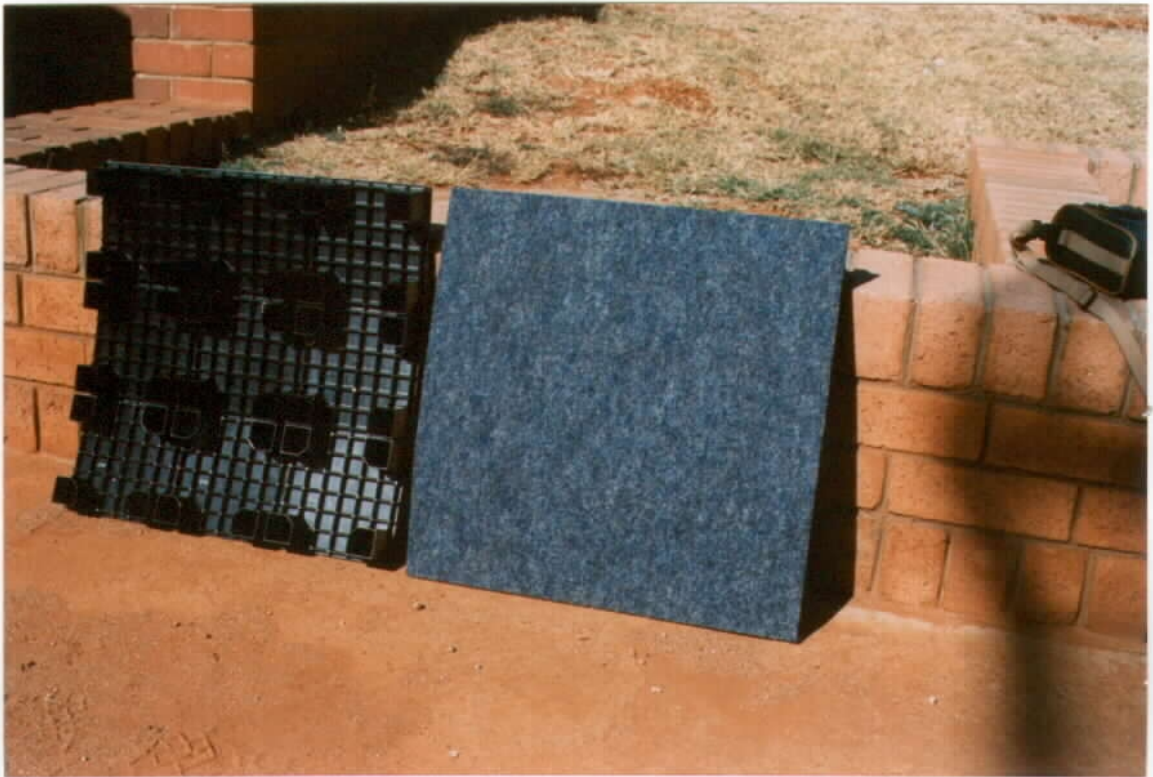
Figure 2: Underside of MicroFloor

MicroFloor raised flooring system consists of pedestals injection moulded from uPVC (PVC Compounders No.R17/J701/901) fitted with adhesive (Pekay Chemicals Neoprene 443) bonded polypropylene carpet squares 500 mm by 500 mm (Dunlop Marathon). Figures 2 and 3 show the structure of the pedestals and attached carpet. The mass of the pedestals and carpet is approximately 7kg/m².

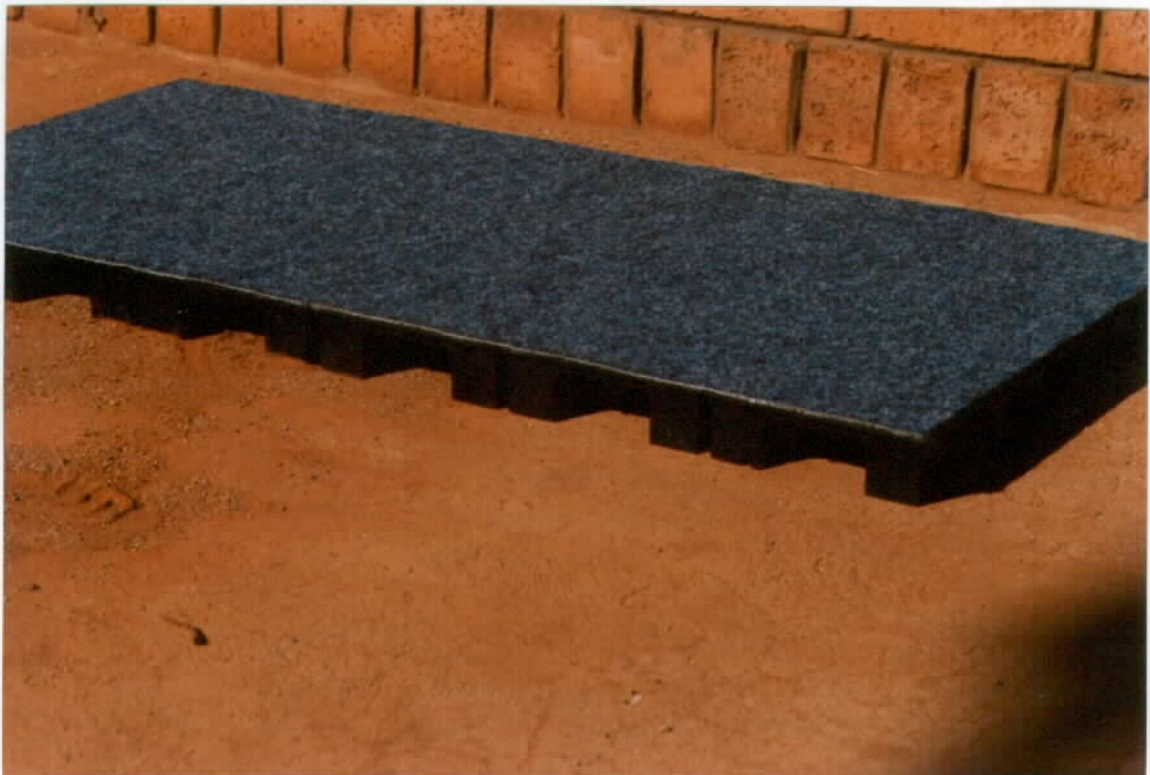
Figure 3: MicroFloor fitted with carpet

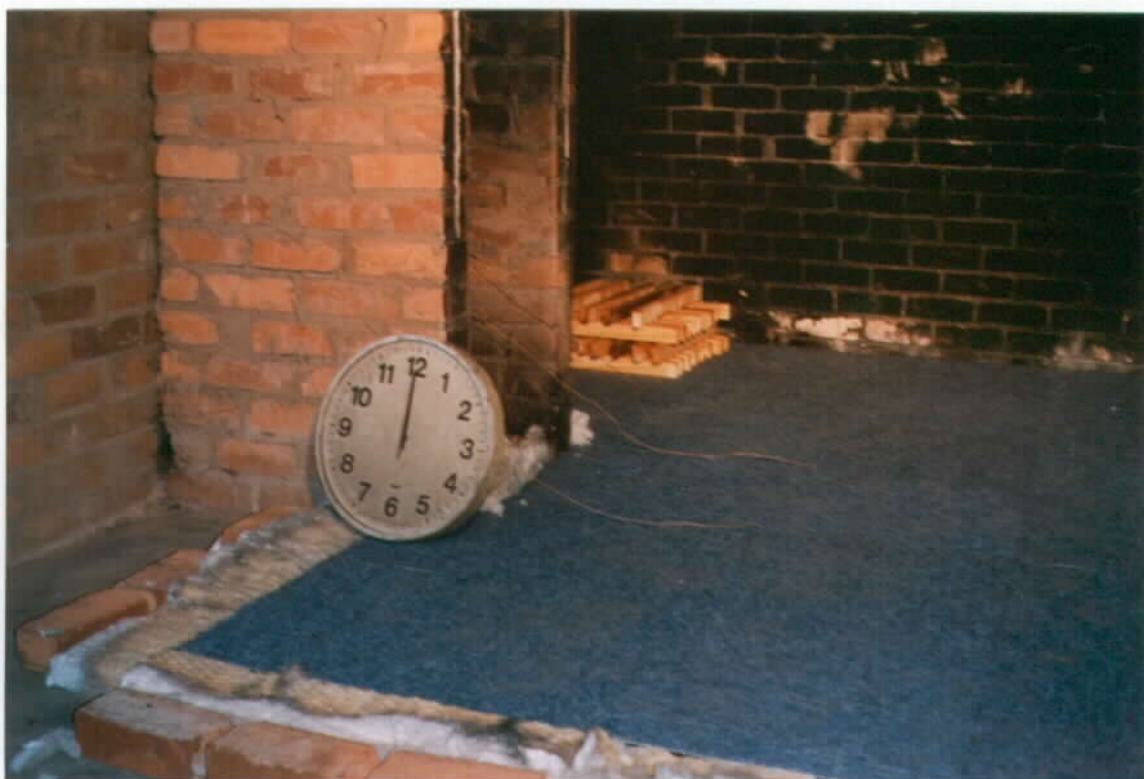
Figure 4: Test arrangement

The MicroFloor pedestals were laid as they would be in practice on a concrete floor in a test room with a ceiling height of 2,9m. A wooden crib consisting of 10 kg of pine laths 600 mm X 60 mm X 25 mm was assembled on one corner of the Microfloor (Figure 4). A little paraffin was applied to the crib to facilitate ignition. Temperatures were measured at one minute intervals by means of thermocouples placed as follows.

- (a) Immediately above the ignition source
- (b) Two meters above the ignition source
- (c) At a join in the carpet tiles 500 mm from the ignition source.
- (d) At a join in the carpet tiles 1 m from the ignition source.
- (e) At a join in the carpet tiles 1,5 m from the ignition source.

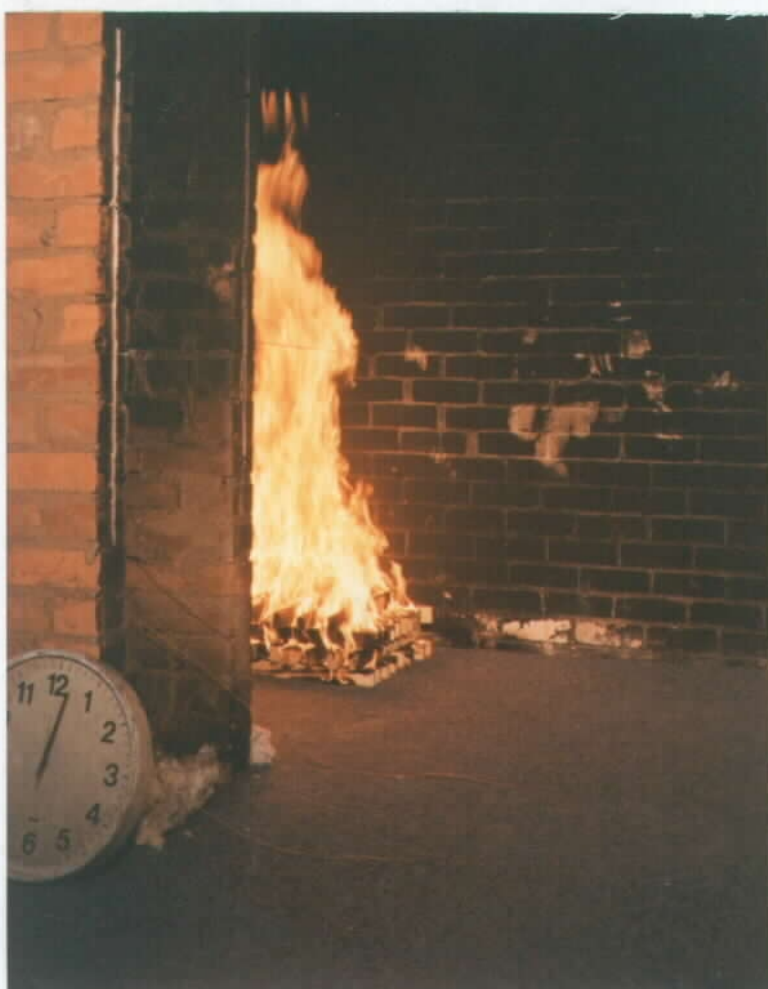
Figure 5: 3 minutes after ignition

TIME (MINS)	OBSERVATIONS
00:00	Ignition of the crib
03:00	Carpet tiles nearest the crib lifting at the edges (Figure 5). Smoke emission moderate with no smell of hydrogen chloride

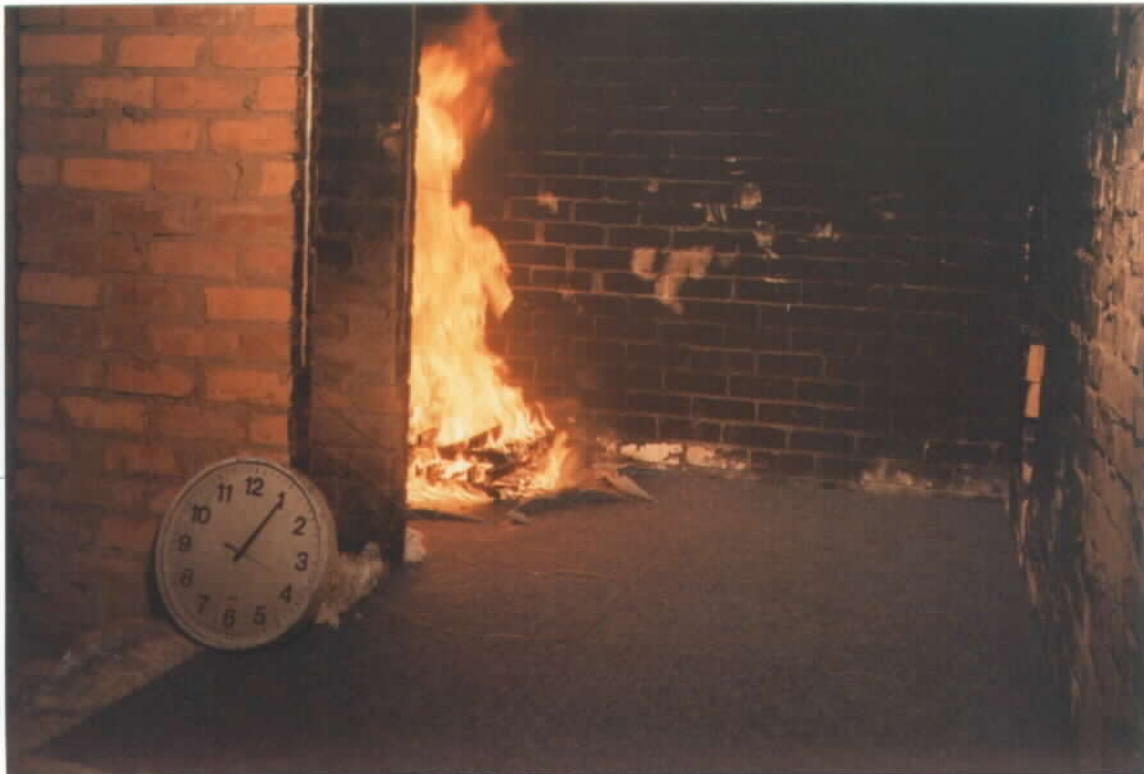
Figure 6: Carpet starting to burn 05:25 minutes after ignition

05:25	Carpet starting to burn in the area nearest the crib (Figure 6). Smoke (not visible in Figure 6 due to buoyancy effect of hot gases) considerable. Hydrogen chloride concentration at 2m above floor and 3m from the ignition source was determined as 2640 ppm (Parts per million)

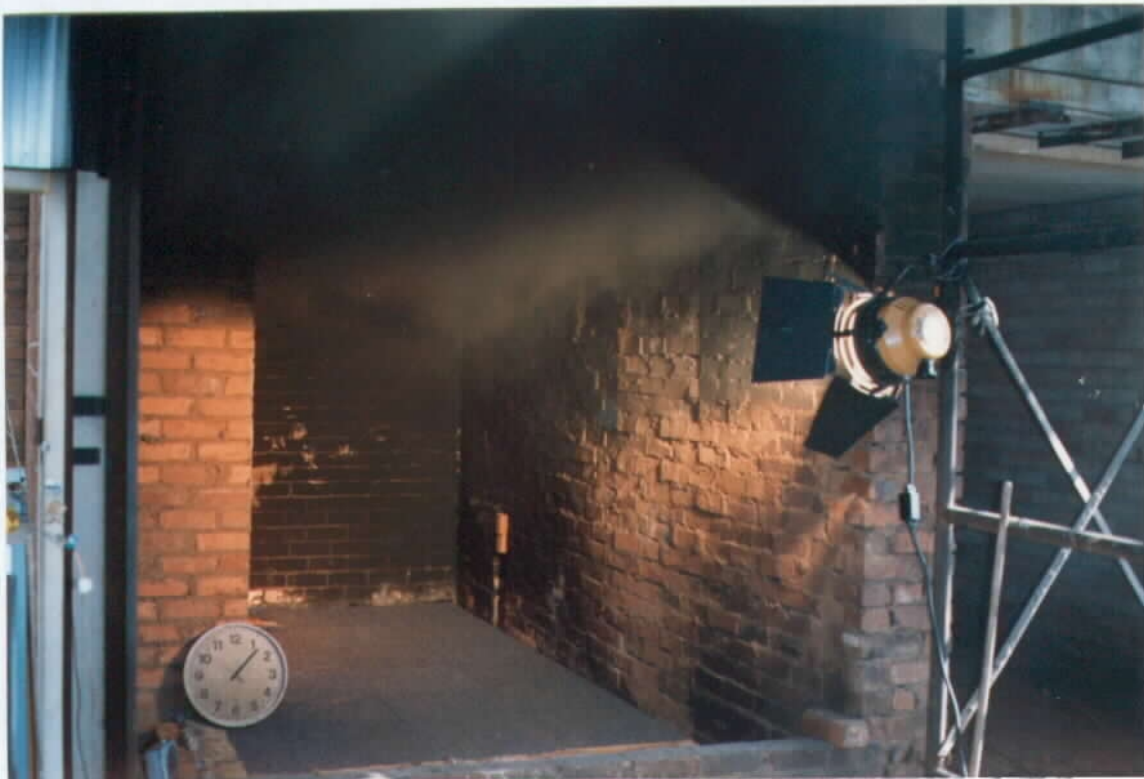
Figure 7: 7 minutes after ignition
Note buoyant smoke cloud

07:00	Smoke considerable (Figure 7)
08:00	uPVC pedestals starting to melt under the carpet tiles
10:00	Ignition crib almost consumed (Figure 8)
11:00	Hydrogen chloride concentration at 2m above the floor and 3m from the ignition source was determined as 3366 ppm

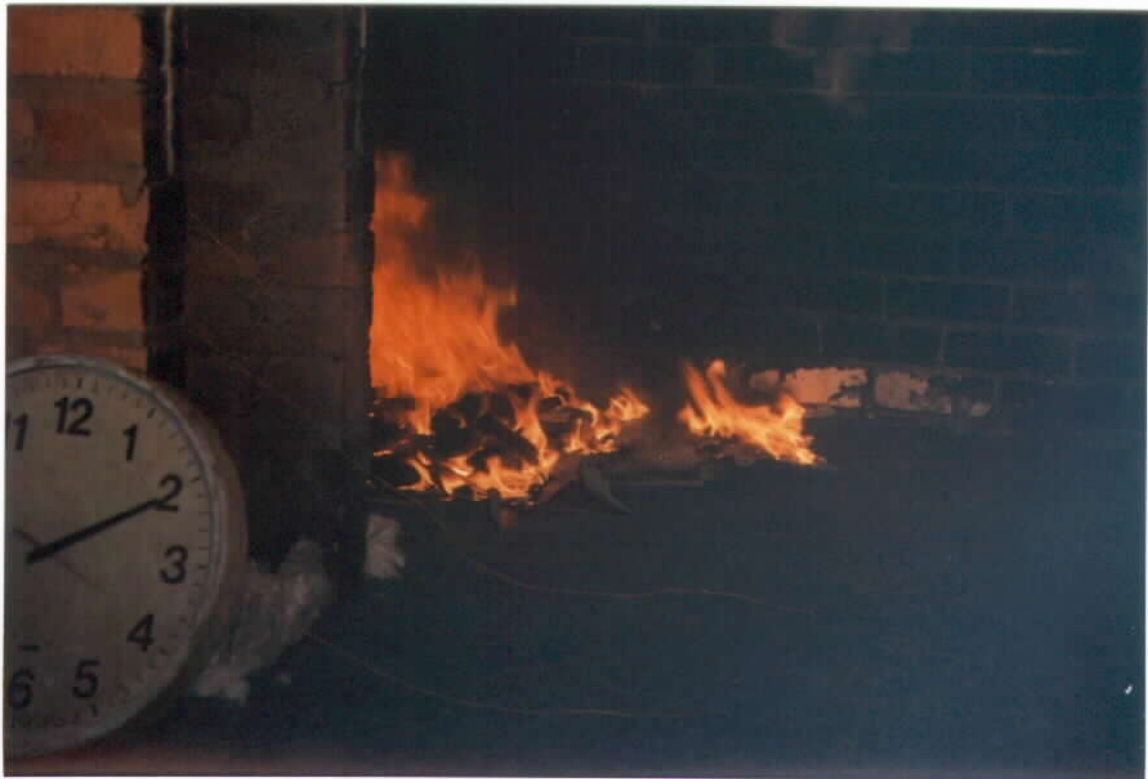
Figure 8: 10 minutes after ignition
Note small extent of flame spread

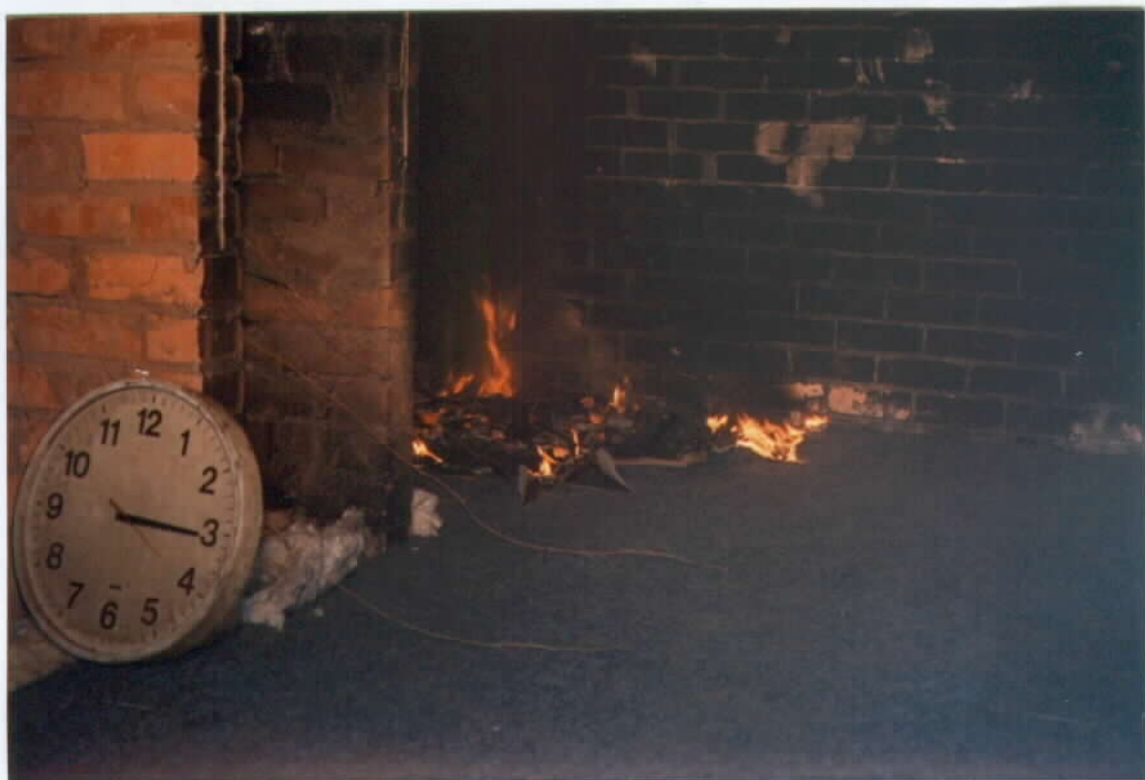
Figure 9: Ignition crib almost consumed

15:00	Ignition crib almost completely consumed - carpet continues to burn slowly - smoke considerable but still buoyant (Figure 9)
17:00	Crib glowing - no flaming combustion - carpet continued to burn slowly

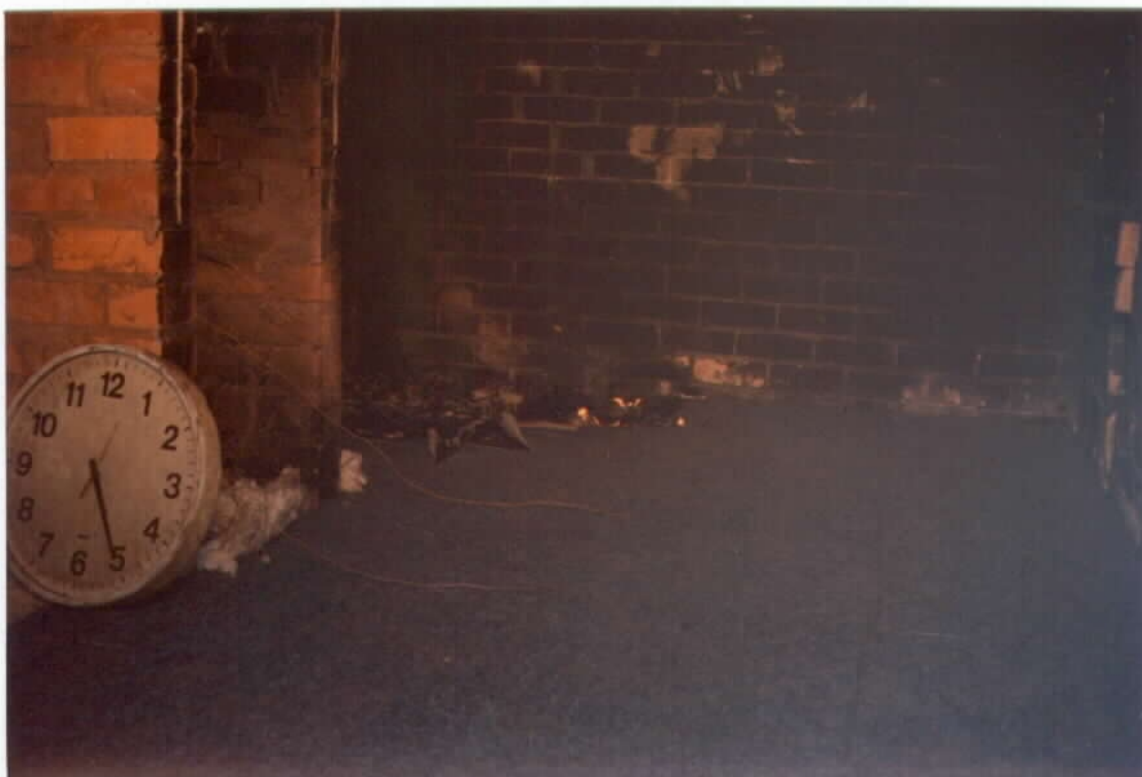
Figure 10: Carpet barely burning

25:05	Crib almost completely extinguished. Carpet only just burning (Figure 10)
43:11	Carpet no longer burning - crib still glowing (Figures 11 and 12)

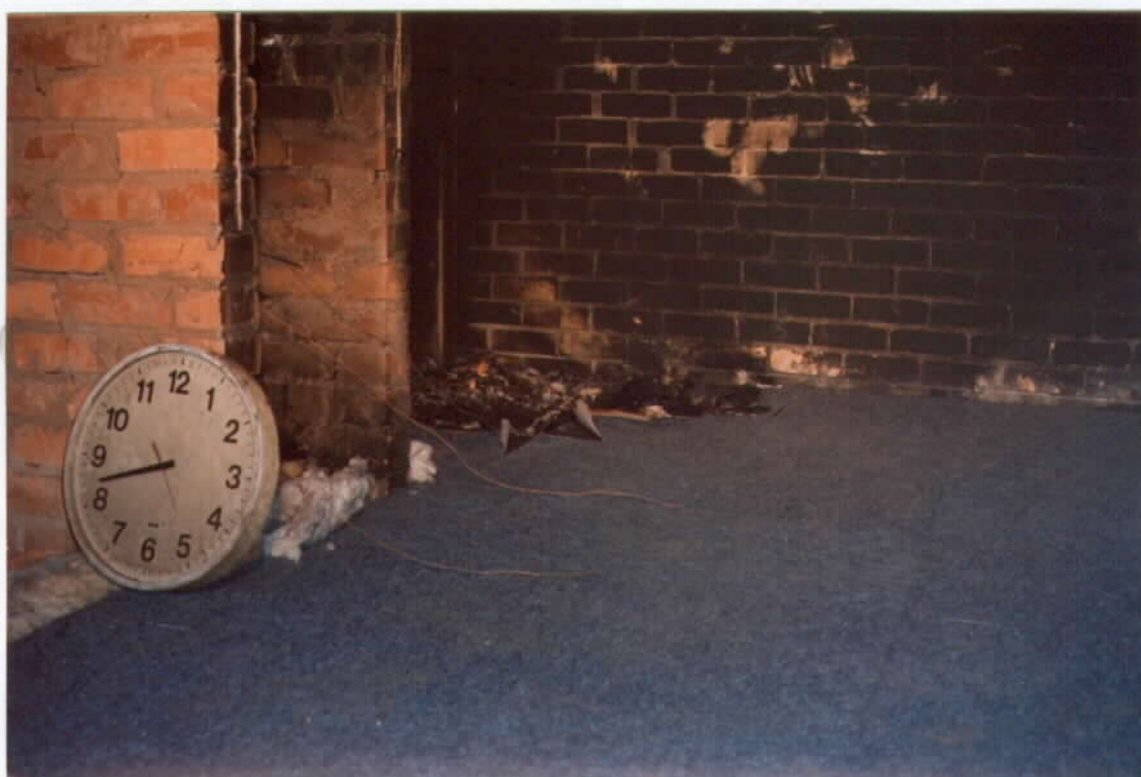
Figure 11: Carpet extinguished - ignition source still glowing

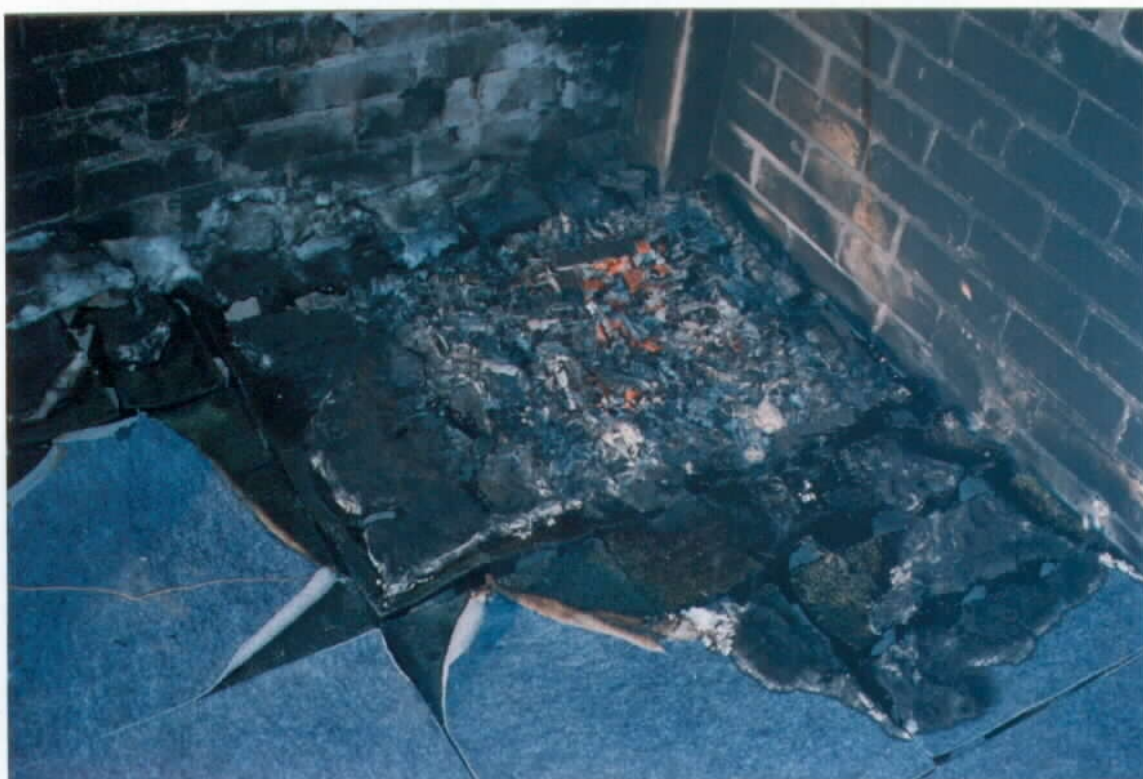
Figure 12: Close-up view of remnants of crib
Note limit of flame spread
