# Klip-Lok / Klip-Tite Dirt Retention Technical Bulletin 1.1

## Technical Bulletin 1:1: Dirt Retention

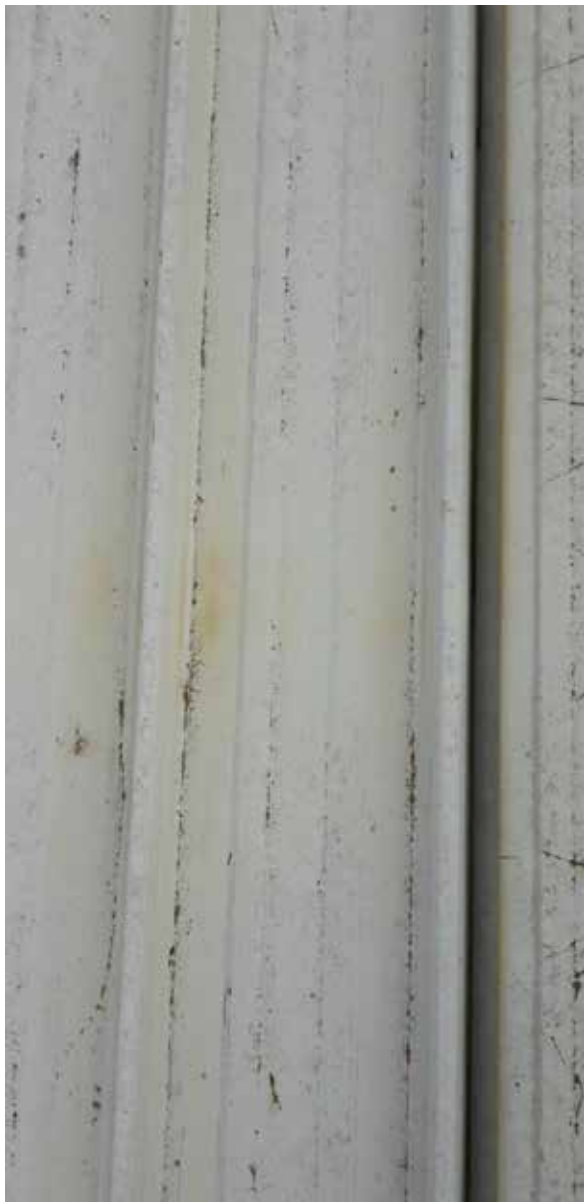
### Klip-Lok

Photographs of two projects of equal age – both installed for about 4.5 years. It is noticeable that most of the dirt (black and brown marks) that accumulates on the roof is trapped at the bottom of the narrow flutes, and the bottom of the sides of the longitudinal pan stiffening ribs with minimal accumulation at the transverse pan stiffeners. The dirt accumulation thus follows the height of the upstand – 41mm at the narrow flute, 2mm at the longitudinal pan stiffeners and 0.5mm at the transverse pan stiffeners.
