50mm MOTORISATION

CTS 40

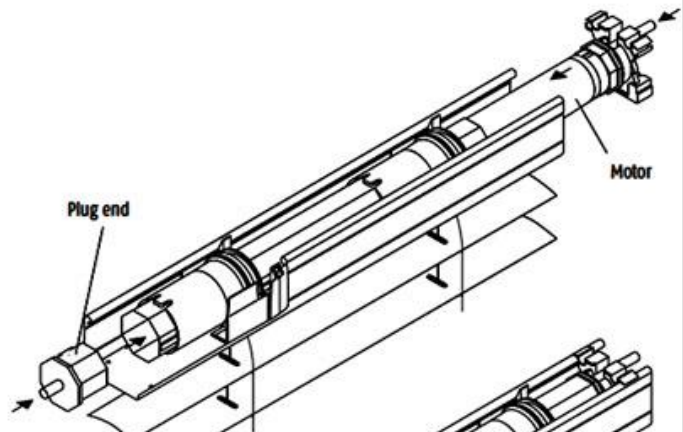
⑬. Turn the tube one half a turn to get the cord knot at the bottom of the headrail. Insert the motor into the headrail and the tube. Insert the plug end. The plug end side gets opposite the holes drilled for access to the limit switches.

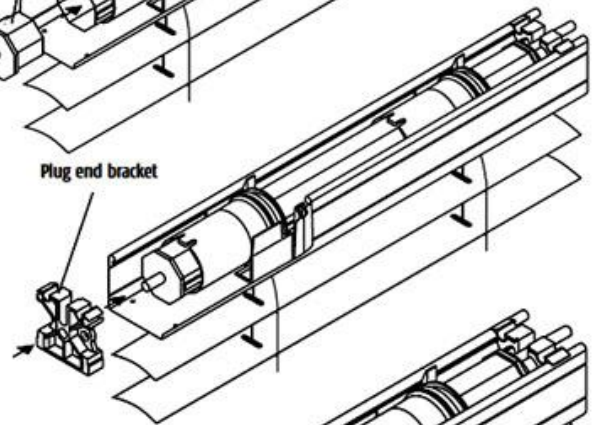
⑭. Insert the plug end bracket into the headrail and onto the plug end.

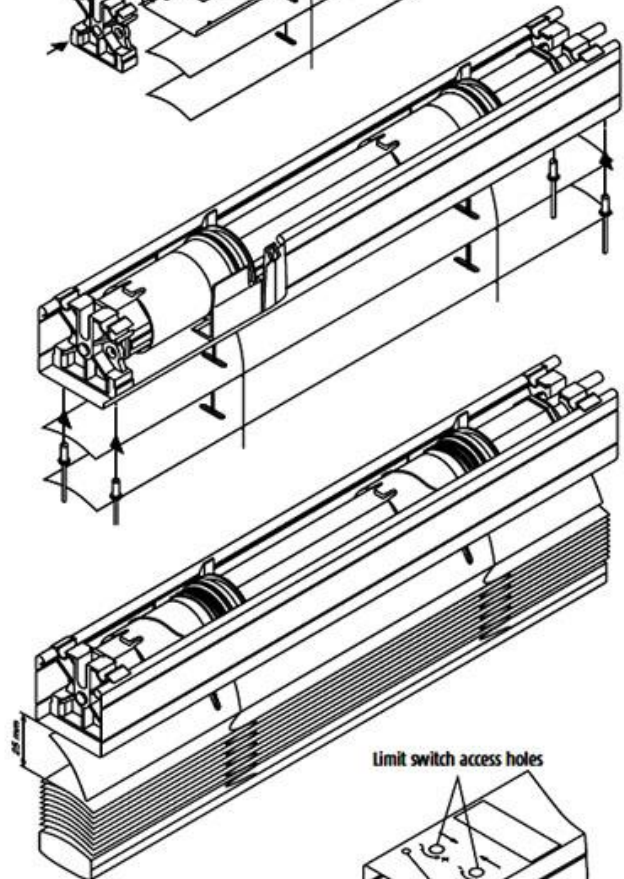
⑯. Adjust the top limit and then readjust the bottom limit if necessary. Check and if necessary adjust the horizontality of the bottom bar.
CAUTION: do not stack the slats completely, leave at least 25 mm, in up position.

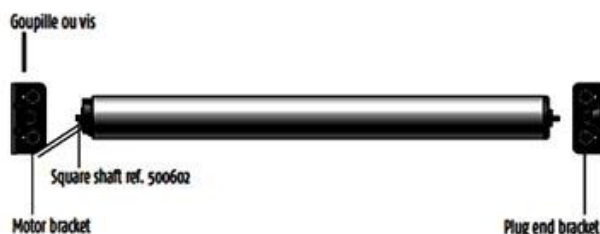
⑤. INSTALLING THE MOTORISED TUBE

Note: Install the motor bracket on the same side as the power supply.

- Fit the brackets, but do not tighten them.
- Fit the plug end bracket over the plug end.
- Ensure that the tube is horizontal using a spirit level.
- Tighten the brackets once it is level.

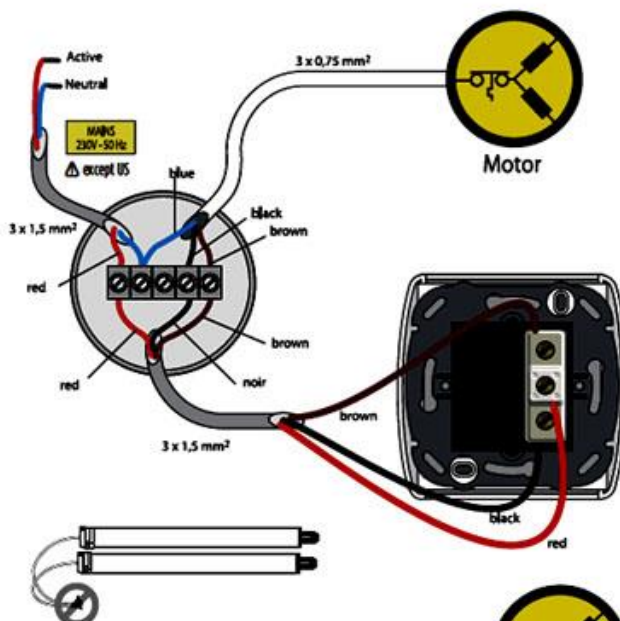
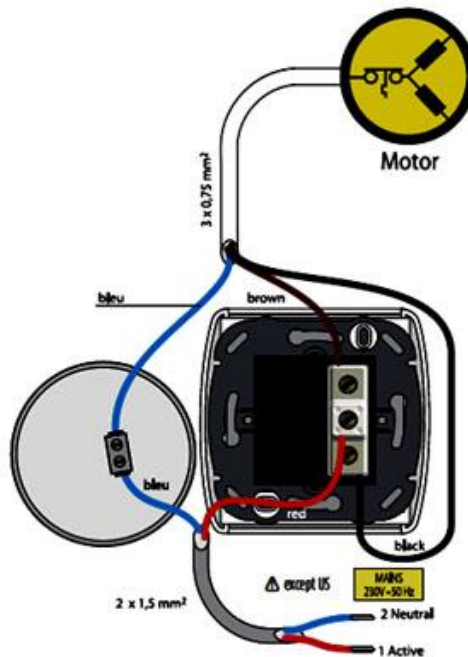
⑦. LIMIT SWITCH SETTING.

Two positions have to be set: the upper and lower limit position. This is where the awning, blind or roller shutter stops automatically:

- 1 - Ensure the switch is at the "STOP" position.
- 2 - Check that the:
 - Up button corresponds to the shutter or blind rolling up
 - Down button corresponds to the shutter or blind rolling down.

If the rotational direction is incorrect, reverse the black and brown wires of the motor (connected to the switch).
